# Manhole Inspection Summary

Manhole # S29CC2010MH

Insp Date: **12/7/06 1:26 PM**

**Location** Address: **5502 GREENLEAF RD**

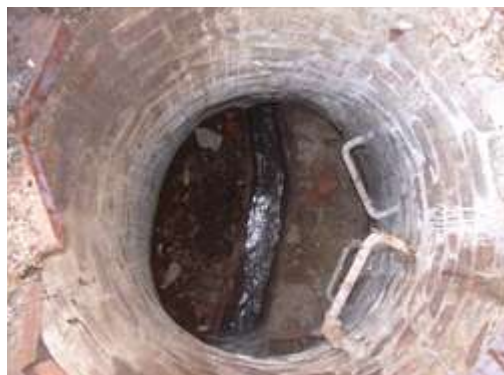
Top View

Evidence of surcharge - Bench debris.

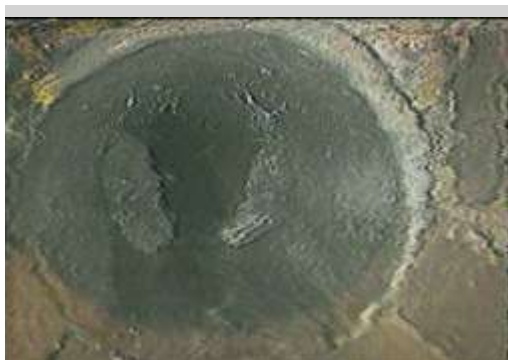
Inside the O12

Root intrusion inside of the O12 pipe.

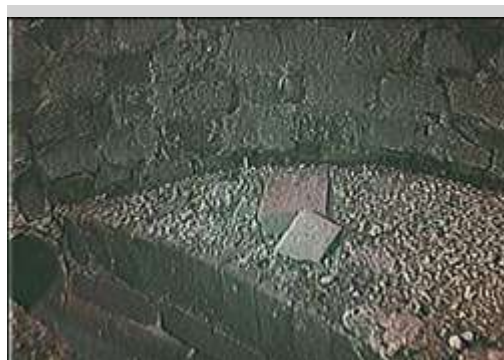
Defect

Barrel deterioration and infiltration.  
Channel deterioration. Bench debris.

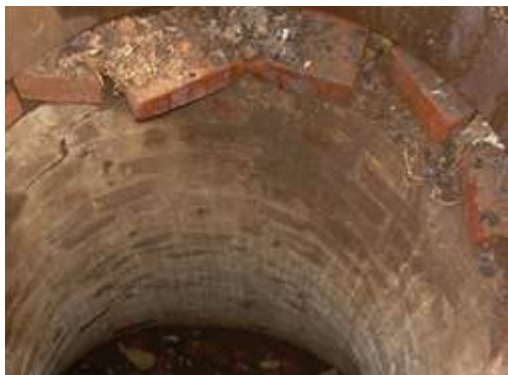
Defect

Frame leaks. Frame offset. Adjustment  
loose brick and infiltration.

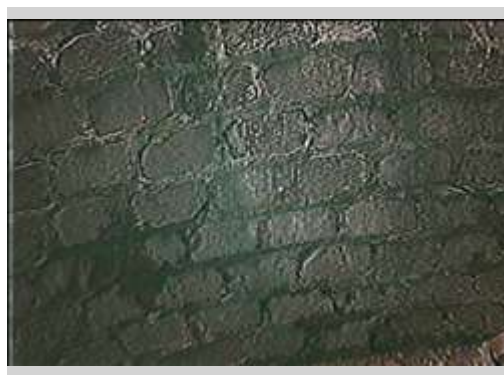
Defect

Barrel deterioration and infiltration.

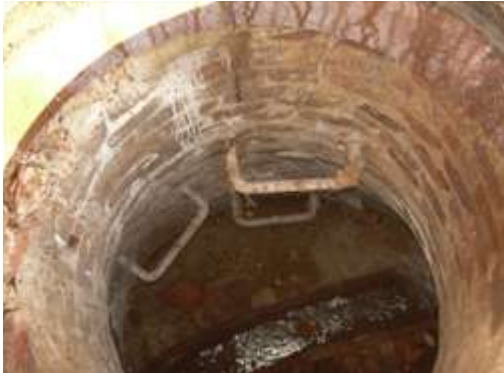
### Defect

Adjustment, Corbel and Barrel infiltration.

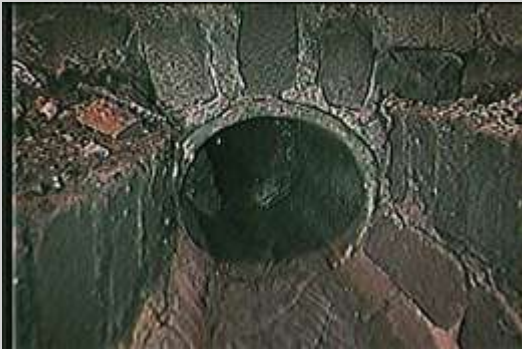
### 8 in. Circular Gravity Sewer Pipe Out @ 12 O'Clock

Infiltration: **Evidence** Pipe Seal Cond: **Unknown**

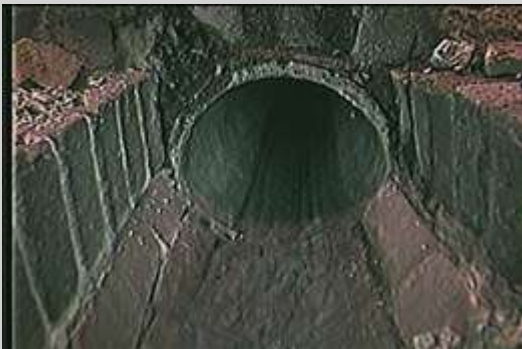
### 8 in. Circular Gravity Sewer Pipe In @ 7 O'Clock

Infiltration: **Evidence** Pipe Seal Cond: **Unknown**
